City of Lakewood

Facility Details

The City of Lakewood

Individual Site Reports

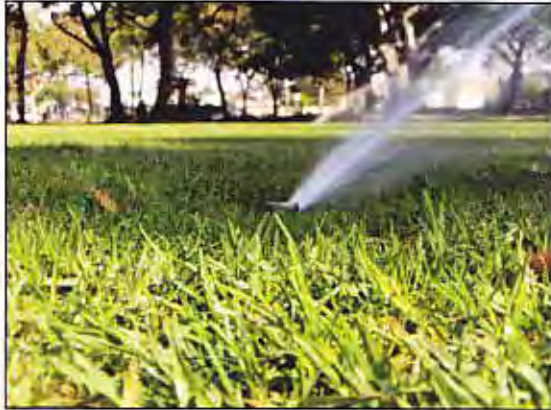
Sprinklers that are installed too low cause spray/stream blockage and create dry circles around the sprinklers.

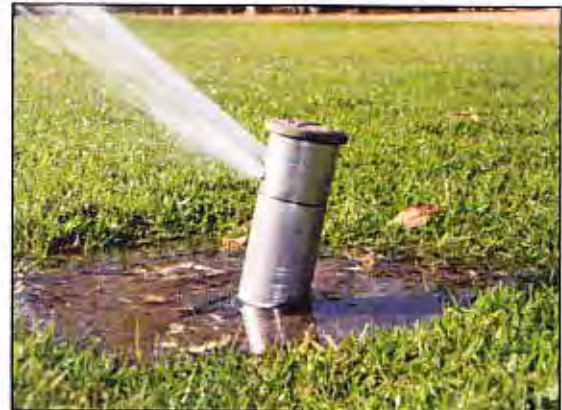
Poor distribution uniformity may be a result of having tipped heads in the irrigation system. Correcting uniformity issues could result in water savings through decreases in run times.

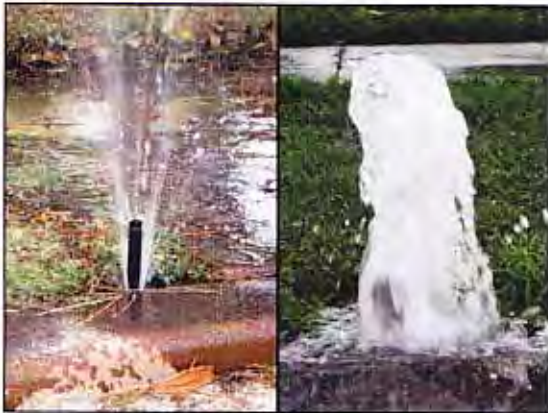
The above photos are examples of leaking and broken heads that are creating major water losses. A broken/leaking head can lead to reduced pressure over an entire station.

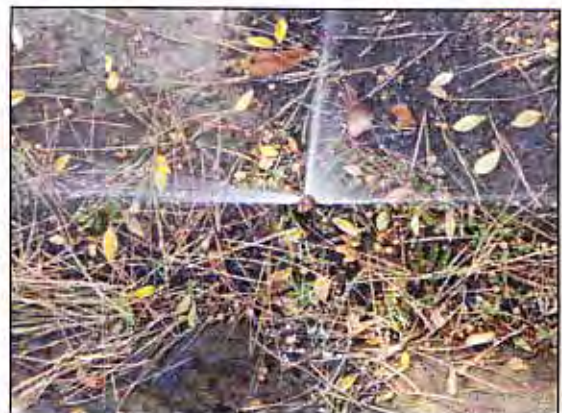
Here is an example of a clogged nozzle. Clogged nozzles at Simon Bolivar Park can be easily reduced by routine maintenance.

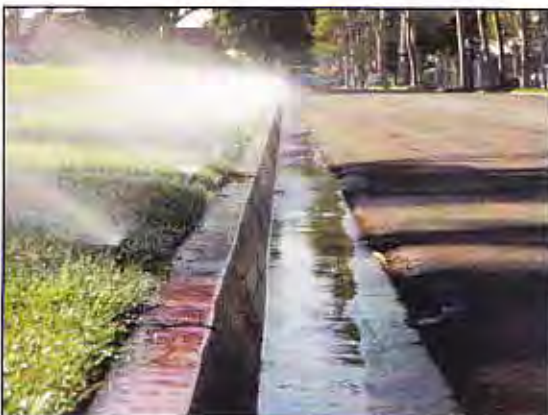
Arc misalignment is a problem that is easy to solve during maintenance. On spray stations, this is causing wasted water and on rotor stations it is also affecting the distribution uniformity.

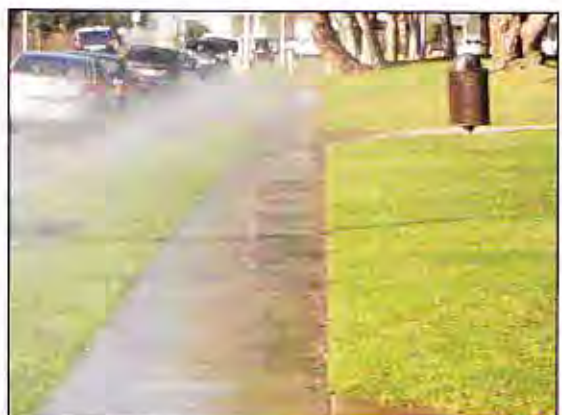
Overspray is often a problem on sidewalks and parkways. We recommend adjusting the radius of throw or replacing the nozzles with strip series nozzles types.

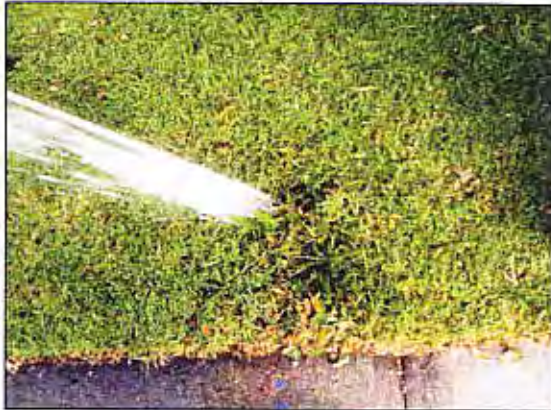
This is an example of a low rotor. Of the 152 rotors that we audited, 14% were low which causes pooling around the base of the rotor and poor distribution uniformity.

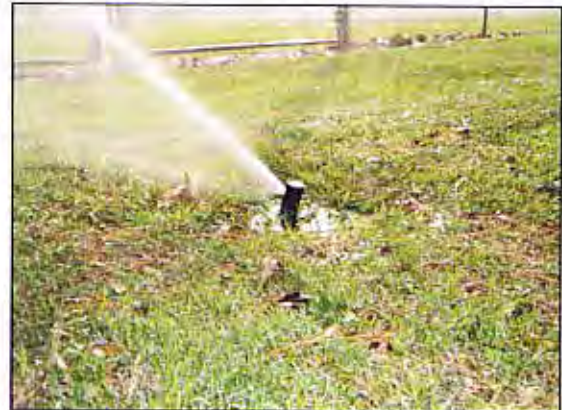
Over 10% of the sprinklers were tipped. Tipped sprinkler heads cause uneven distribution of water.

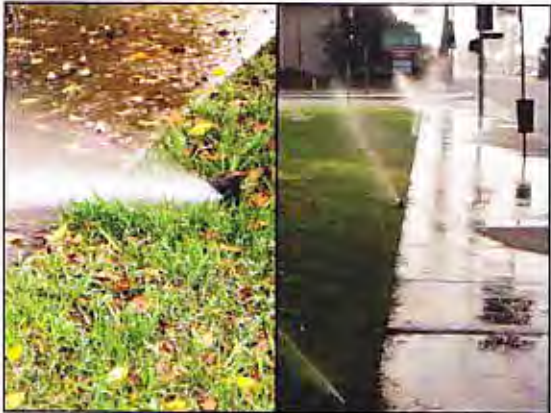
Here are two examples of arc misalignment. The arc on these rotor heads should be rotated to water the lawn area instead of the sidewalks.

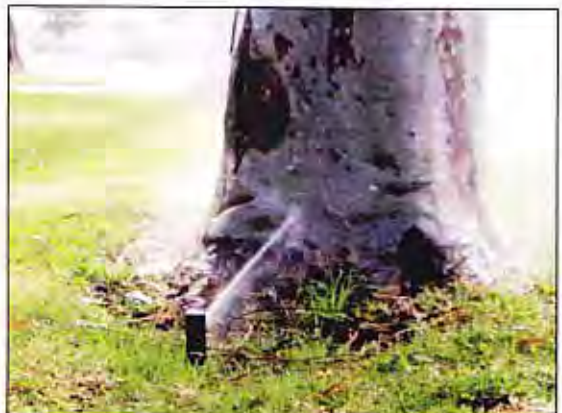
Here is an example of a blocked rotor of 14 blocked rotors we found. This is not only unhealthy for the tree but, inefficient for the uniformity of water being distributed.

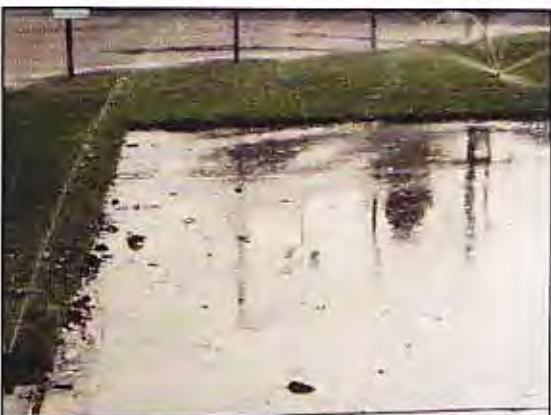
Station 5, was battery operated and overspraying onto a hardscape. We recommend either adjusting the radius of throw or downsizing nozzles.

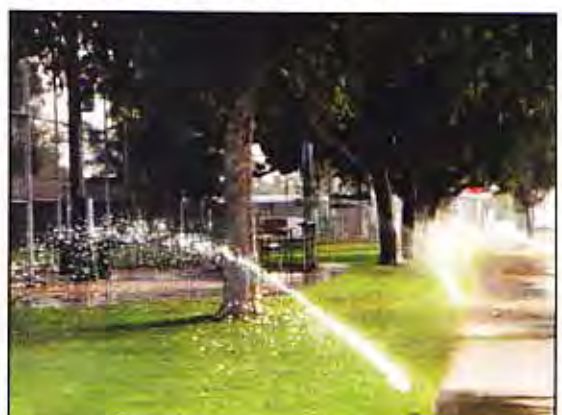
Of the 11 active stations at Controller I which were irrigating large lawn areas, 8 stations were operating at lower than optimum pressure. Check the control valves or downsize the nozzles.

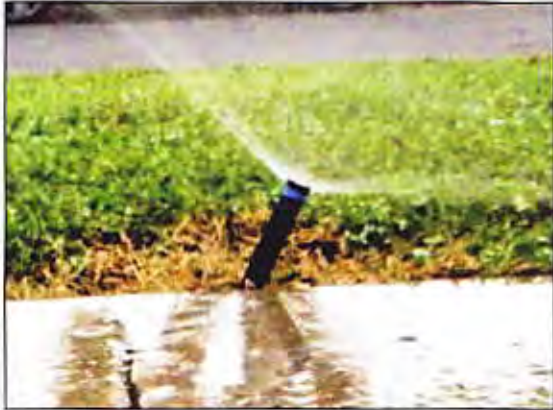
About 14% of the sprinklers were tipped. Tipped sprinkler heads cause uneven distribution of water.

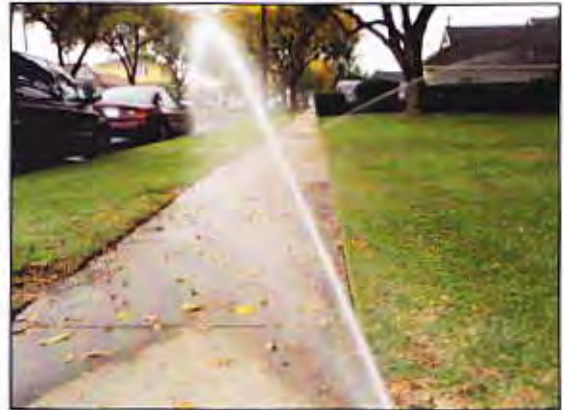
Here is an example of a rotor with arc misalignment. A total of 34 sprinklers at Biscailuz Park were out of alignment.

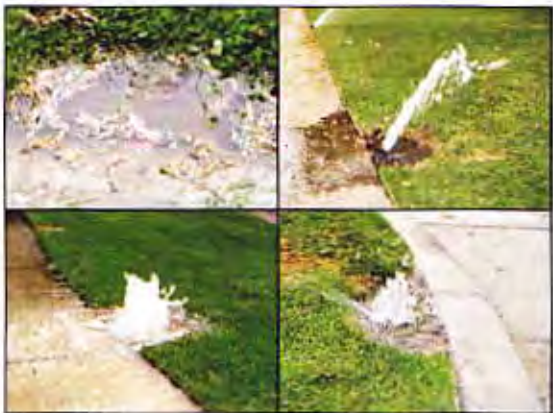
Over 25% of the sprinklers at Controller I were found broken. Broken sprinklers should be kept to a minimum with maintenance, these broken sprinklers are creating major water losses.

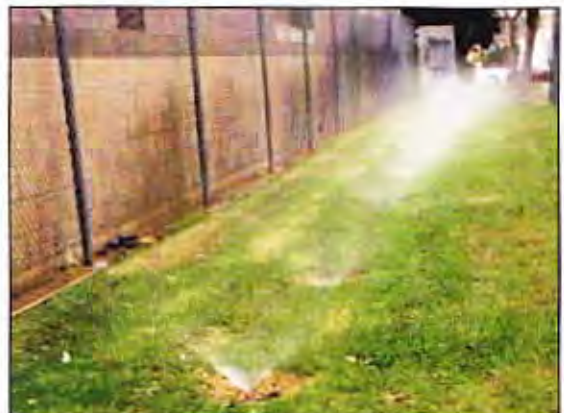
The above photo shows low sprinkler heads with high water pressure resulting in misting. Misting can be fixed by adding pressure regulators.

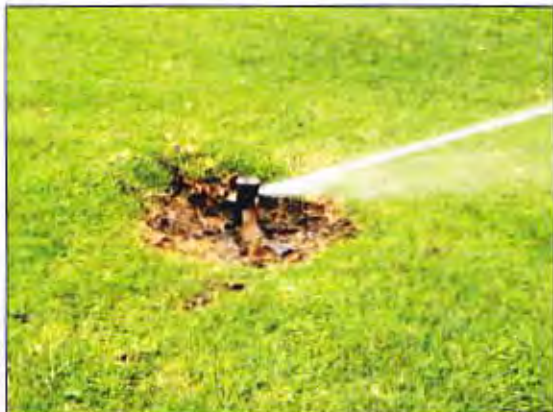
This photo shows a low rotor. Low sprinklers produce poor water distribution uniformity and pooling at the base of the sprinkler.

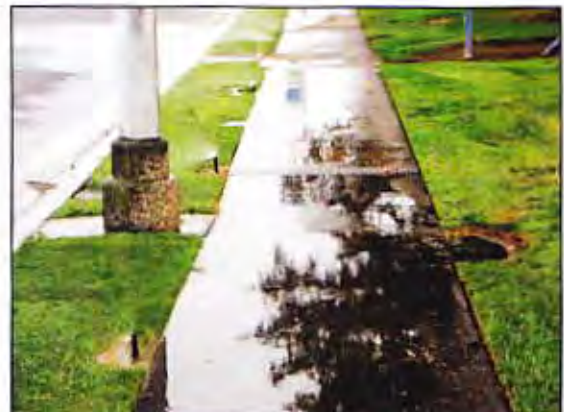
Overspray is often a problem on sidewalks and parkways. We recommend replace the nozzles with strip series nozzle types at stations 4 and 10 Controller I and manual station 5.
